**Flood Control Project Maintenance  
Levee Inspections**

**Maintenance Issue Types Only, Levee Inspection Report By Mile - Fall 2018**

**Reclamation District No. 2060 Hastings**

Waterway	Bank	Unit Miles	Inspection Start/End	Inspector
Unit No. 01 Lindsey Slough	Left	6.97	10/25/2018 10/25/2018	David Julian

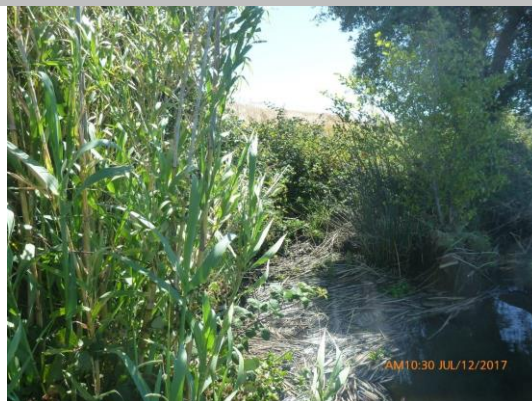
Photo 1 of 6 : FA\_2018\_RD2060\_241\_5\_20180925\_00001.jpg

LM Start	0.40	Rating **	M	Issue No.	5
LM End	0.40	Issue Type +	Ma	Location *	WS
Category	Supplemental			GPS Latitude/Longitude	
				Start	End
Item	2017 Storm Damage			38.247894 °	38.247911 °
				-121.703492 °	-121.703539 °
DWR ID	DWR_RD2060_01_f _ 2017_5				
Comment Code					
Inspector Comment					
Levee Evaluation Comments					
Description:Erosion commences approximately 3/4 of the way down the slope, near the water line towards the waterside toe.					
Site ID No:358					
Site Designation:LMA-185					
Repair Type: Erosion					
Rating:Area of Concern					
Field Date:7/12/2017					
Notes: Small erosion into bank.

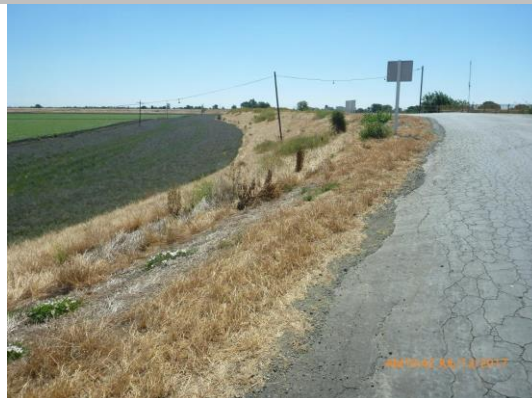
Photo 5 of 6 : FA\_2018\_RD2060\_241\_5\_20180925\_00005.jpg

LM Start	0.40	Rating **	M	Issue No.	5 (cont)	
LM End	0.40	Issue Type +	Ma	Location *	WS	
Category	Supplemental			GPS Latitude/Longitude		
				Start		End
Item	2017 Storm Damage			38.247894 °		38.247911 °
				-121.703492 °		-121.703539 °
DWR ID	DWR_RD2060_01_f _ 2017_5					
Comment Code						
Inspector Comment						
Levee Evaluation Comments						
Description:Erosion commences approximately 3/4 of the way down the slope, near the water line towards the waterside toe.						
Site ID No:358						
Site Designation:LMA-185						
Repair Type: Erosion						
Rating:Area of Concern						
Field Date:7/12/2017						
Notes: Small erosion into bank.

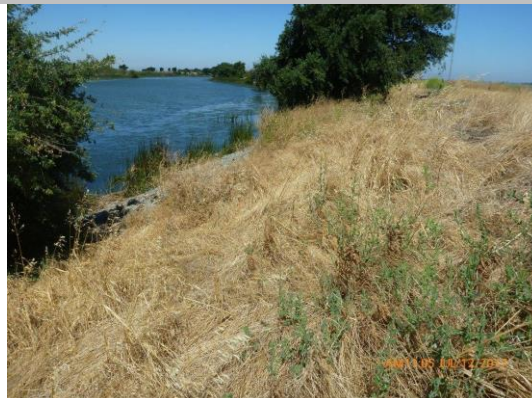
Photo 3 of 3 : FA\_2018\_RD2060\_241\_8\_20180925\_00009.jpg

LM Start	0.41	Rating **	M	Issue No.	8 (cont)
LM End	0.42	Issue Type +	Ma	Location *	WS
Category	Supplemental			GPS Latitude/Longitude	
				Start	End
Item	2017 Storm Damage			38.248036 °	38.248017 °
				-121.703539 °	-121.703789 °
DWR ID	DWR_RD2060_01_f_2017_8				
Comment Code					
Inspector Comment					
Levee Evaluation Comments					
Description:Erosion commences approximately halfway down the water side slope extending in to existing rip rap. Existing rip rap appears to have been pulled off in this section.					
Site ID No:359					
Site Designation:LMA-186					
Repair Type: Erosion					
Rating:Area of Concern					
Field Date:7/12/2017					
Notes: Site had riprap but is eroded away. Minor erosion in toe of levee.

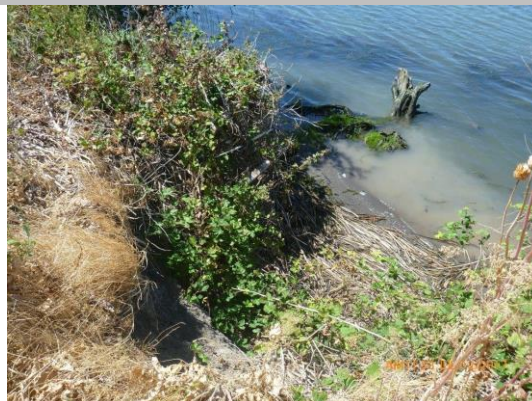
LM Start	0.75	Rating **	M	Issue No.	9
LM End	0.76	Issue Type +	Ma	Location *	WS
Category	Supplemental			GPS Latitude/Longitude	
				Start	End
Item	2017 Storm Damage			38.249314 °	38.249400 °
				-121.709461 °	-121.709608 °
DWR ID	DWR_RD2060_01_f_2017_9				
Comment Code					
Inspector Comment					
Levee Evaluation Comments					
Description: Erosion commences approximately halfway down the water side slope extending in to existing rip rap. Erosion is concentrated near the waterline. Existing rip rap appears to have been pulled off in this section.					
Site ID No:360					
Site Designation:LMA-187					
Repair Type: Erosion					
Rating:Area of Concern					
Field Date:7/12/2017					
Notes: Erosion looks old but has progressed this year.

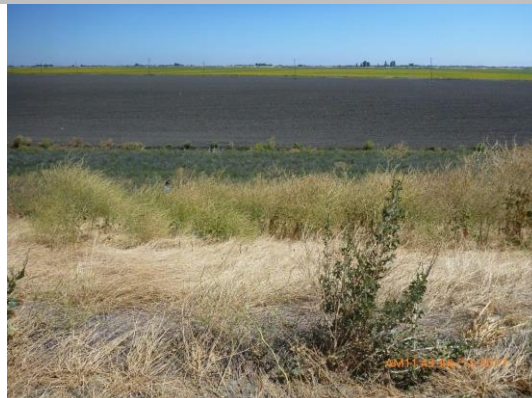
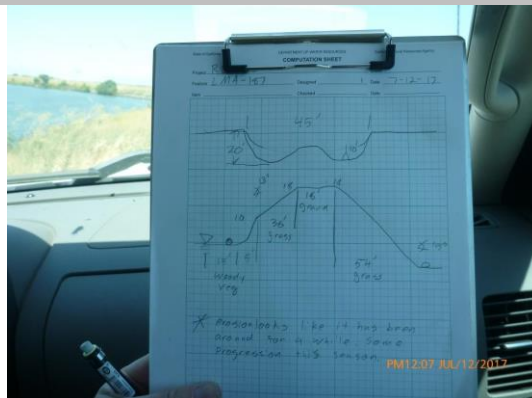
Photo 3 of 3 : FA\_2018\_RD2060\_241\_9\_20180925\_00012.jpg

LM Start	<b>0.75</b>	Rating **	M	Issue No.	<b>9 (cont)</b>							
LM End	<b>0.76</b>	Issue Type +	Ma	Location *	WS							
Category	Supplemental		GPS Latitude/Longitude									
			Start	End								
Item	2017 Storm Damage		38.249314 °	38.249400 °								
			-121.709461 °	-121.709608 °								
DWR ID	DWR_RD2060_01_f_2017_9											
Comment Code												
Inspector Comment												
<b>Levee Evaluation Comments</b> Description: Erosion commences approximately halfway down the water side slope extending in to existing rip rap. Erosion is concentrated near the waterline. Existing rip rap appears to have been pulled off in this section. Site ID No: 360 Site Designation: LMA-187 Repair Type: Erosion Rating: Area of Concern Field Date: 7/12/2017 Notes: Erosion looks old but has progressed this year.

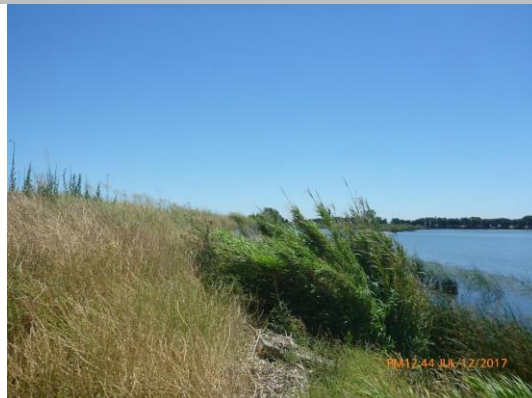
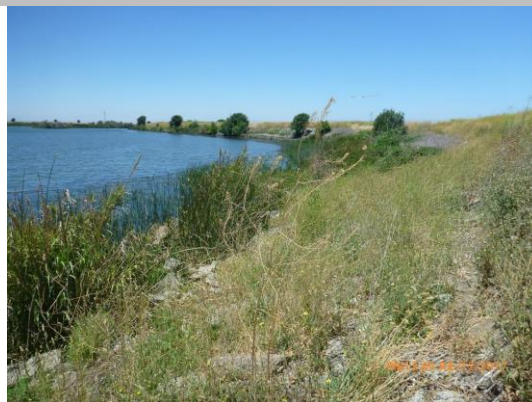
Photo 4 of 4 : FA\_2018\_RD2060\_241\_10\_20180925\_00016.jpg

LM Start	0.92	Rating **	M	Issue No.	10 (cont)
LM End	0.93	Issue Type +	Ma	Location *	WS
Category	Supplemental			GPS Latitude/Longitude	
				Start	End
Item	2017 Storm Damage			38.250875 °	38.250953 °
				-121.711942 °	-121.712078 °
DWR ID	DWR_RD2060_01_f_2018_10				
Comment Code					
Inspector Comment					
Levee Evaluation Comments					
Description:Sloughing commences approximately halfway down the water side slope.					
Site ID No:361					
Site Designation:LMA-188					
Repair Type: Erosion					
Rating:Area of Concern					
Field Date:7/12/2017					
Notes: Minor sloughing, mostly riprap has moved down the slope and into channel.

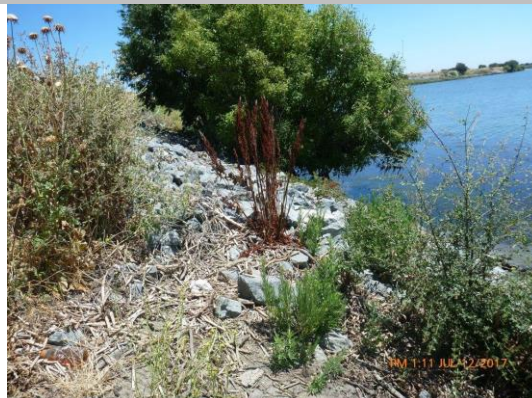
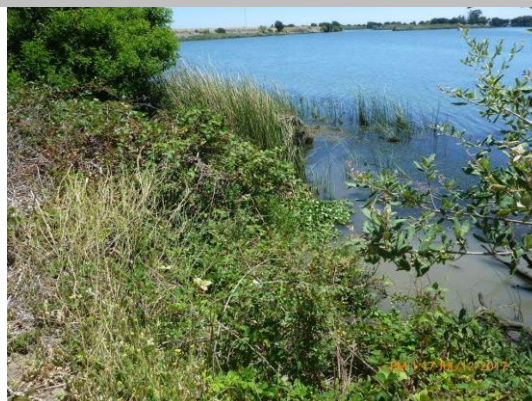
LM Start	1.04	Rating **	M	Issue No.	15 (cont)
LM End	1.08	Issue Type +	Ma	Location *	WS
Category	Supplemental			GPS Latitude/Longitude	
				Start	End
Item	2017 Storm Damage			38.251058 °	38.250872 °
				-121.714050 °	-121.714792 °
DWR ID	DWR_RD2060_01_f_2017_15				
Comment Code					
Inspector Comment					
Levee Evaluation Comments					
Description:Erosion commences approximately 3/4 of the way down the water side slope concentrated at the waterline.					
Site ID No:362					
Site Designation:LMA-189					
Repair Type: Erosion					
Rating:Area of Concern					
Field Date:7/12/2017					
Notes: Erosion due to lack of revetment. Erosion ends at riprap downstream. Vertical cut at summer wse.

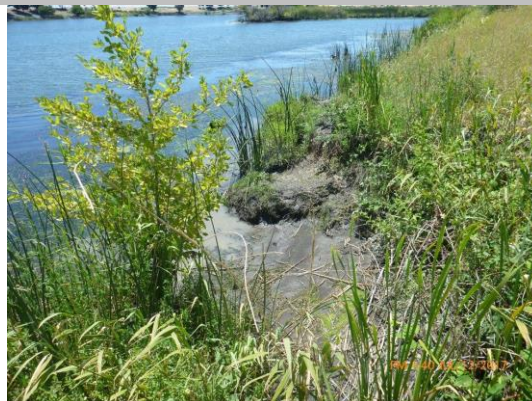
LM Start	1.09	Rating **	M	Issue No.	16
LM End	1.10	Issue Type +	Ma	Location *	WS
Category	Supplemental			GPS Latitude/Longitude	
				Start	End
Item	2017 Storm Damage			38.250844 °	38.250833 °
				-121.714944 °	-121.714994 °
DWR ID	DWR_RD2060_01_f_2017_16				
Comment Code					
Inspector Comment					
Levee Evaluation Comments					
Description:Erosion commences approximately halfway down the water side slope extending to the toe.					
Site ID No:363					
Site Designation:LMA-190					
Repair Type: Erosion					
Rating:Area of Concern					
Field Date:7/12/2017					
Notes: Small erosion up to high water line. Cuts into slope with 6' vertical cut.

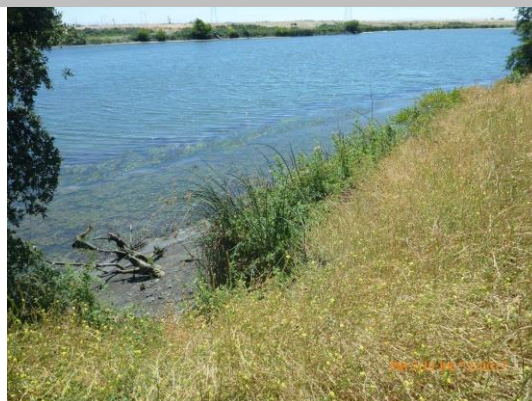
LM Start	1.39	Rating **	A/W	Issue No.	20 (cont)
LM End	1.56	Issue Type +	Ma	Location *	WS
Category	Supplemental			GPS Latitude/Longitude	
				Start	End
Item	2017 Storm Damage			38.251886 °	38.252619 °
				-121.719933 °	-121.722842 °
DWR ID	DWR_RD2060_01_f_2017_20				
Comment Code					
Inspector Comment					
Levee Evaluation Comments					
Description:Erosion commences approximately halfway down the water side slope extending to the toe.					
Site ID No:365					
Site Designation:LMA-192					
Repair Type: Erosion					
Rating:Serious					
Field Date:7/12/2017					
Notes: Several deep narrow cuts into levee, but mostly minor erosion at highwater line.

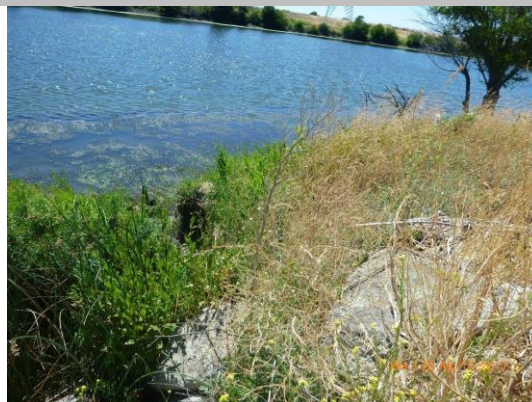
LM Start	1.81	Rating **	A/W	Issue No.	21 (cont)
LM End	1.84	Issue Type +	Ma	Location *	WS
Category	Supplemental			GPS Latitude/Longitude	
				Start	End
Item	2017 Storm Damage			38.255972 °	38.256247 °
				-121.724197 °	-121.724464 °
DWR ID	DWR_RD2060_01_f_2017_21				
Comment Code					
Inspector Comment					
Levee Evaluation Comments					
Description:Erosion commences approximately halfway down the water side slope extending to the toe. Some slipping into the toe has occurred due to deep erosion.					
Site ID No:366					
Site Designation:LMA-193					
Repair Type: Erosion					
Rating:Serious					
Field Date:7/12/2017					
Notes: Erosion extends halfway into the slope.

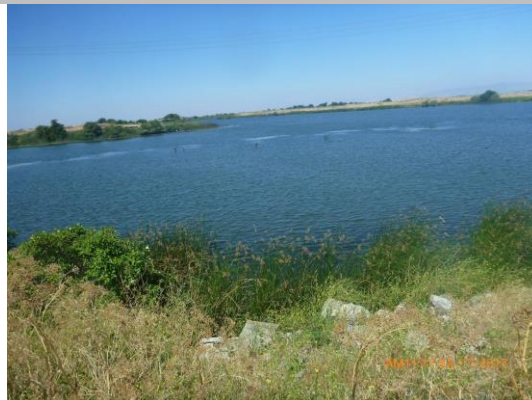
LM Start	1.90	Rating **	M	Issue No.	22 (cont)
LM End	1.95	Issue Type +	Ma	Location *	WS
Category	Supplemental			GPS Latitude/Longitude	
				Start	End
Item	2017 Storm Damage			38.257208 °	38.257842 °
				-121.724619 °	-121.724694 °
DWR ID	DWR_RD2060_01_f_2017_22				
Comment Code					
Inspector Comment					
Levee Evaluation Comments					
Description:Erosion commences approximately halfway down the water side slope extending to the toe. Some slipping into the toe has occurred.					
Site ID No:367					
Site Designation:LMA-194					
Repair Type: Erosion					
Rating:Area of Concern					
Field Date:7/12/2017					
Notes: Minor crackingobserved below the hinge point and minor erosion at levee toe.

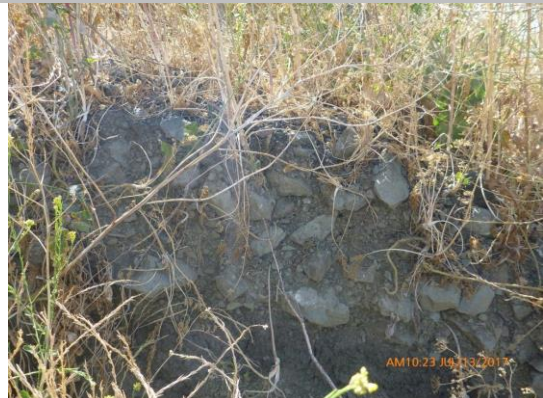
LM Start	2.10	Rating **	A/W	Issue No.	23
LM End	2.13	Issue Type +	Ma	Location *	
Category	Supplemental			GPS Latitude/Longitude	
				Start	End
Item	2017 Storm Damage			38.259317 °	38.259258 °
				-121.726314 °	-121.726939 °
DWR ID	DWR_RD2060_01_f _ 2017_23				
Comment Code					
Inspector Comment					
Levee Evaluation Comments					
Description:Erosion commences approximately halfway down the water side slope extending to the rip rap.					
Site ID No:368					
Site Designation:LMA-195					
Repair Type: Erosion					
Rating:Serious					
Field Date:7/13/2017					
Notes: Erosion appears to be previously repaired, but has failed again.

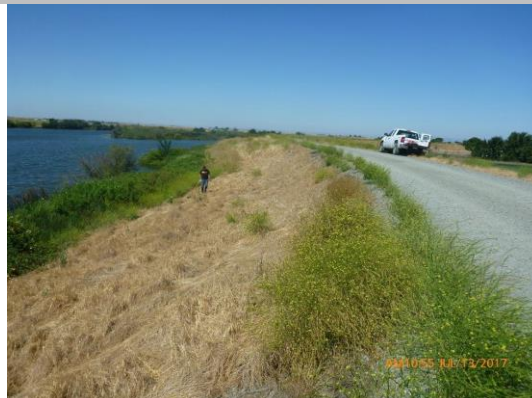
LM Start	2.57	Rating **	M	Issue No.	24 (cont)
LM End	2.60	Issue Type +	Ma	Location *	WS
Category	Supplemental			GPS Latitude/Longitude	
				Start	End
Item	2017 Storm Damage			38.257467°	38.257286°
				-121.734153°	-121.734683°
DWR ID	DWR_RD2060_01_f_2017_24				
Comment Code					
Inspector Comment					
Levee Evaluation Comments					
Description:Erosion commences approximately halfway down the water side slope. Part of the levee has sloughed down toward the waterline where further erosion occurs.					
Site ID No:369					
Site Designation:LMA-196					
Repair Type: Erosion					
Rating:Area of Concern					
Field Date:7/13/2017					
Notes: Levee slope is concave due slumping. Erosion at waterline.

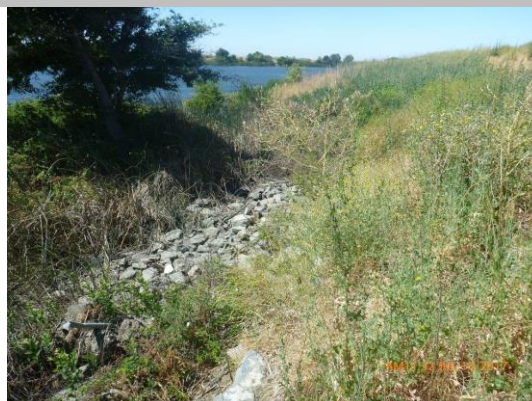
LM Start	3.07	Rating **	A/W	Issue No.	25
LM End	3.10	Issue Type +	Ma	Location *	
Category	Supplemental			GPS Latitude/Longitude	
				Start	End
Item	2017 Storm Damage			38.260772 °	38.260569 °
				-121.740817 °	-121.741194 °
DWR ID	DWR_RD2060_01_f_2017_25				
Comment Code					
Inspector Comment					
Levee Evaluation Comments					
Description:Erosion occurs near the waterline. Part of the levee has sloughed down toward the waterline due to erosion.					
Site ID No:370					
Site Designation:LMA-197					
Repair Type: Erosion					
Rating:Serious					
Field Date:7/13/2017					
Notes: Large erosion halfway into levee. Horizontal cracking on slope almost 24"deep.

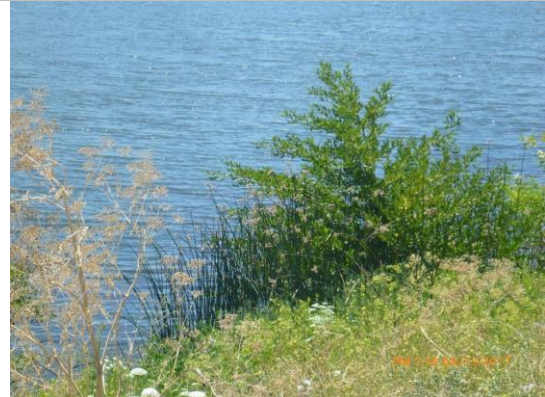
LM Start	3.60	Rating **	M	Issue No.	27
LM End	3.61	Issue Type +	Ma	Location *	
Category	Supplemental			GPS Latitude/Longitude	
				Start	End
Item	2017 Storm Damage			38.261469 °	38.261464 °
				-121.748389 °	-121.748442 °
DWR ID	DWR_RD2060_01_f _ 2017_27				
Comment Code					
Inspector Comment					
Levee Evaluation Comments					
Description:Erosion commences halfway down the slope and extends to the toe. Erosion is concentrated at the water line.					
Site ID No:373					
Site Designation:LMA-200					
Repair Type: Erosion					
Rating:Area of Concern					
Field Date:7/13/2017					
Notes: Small erosion with a narrow deep cut. Heavy veg is protecting the slope.

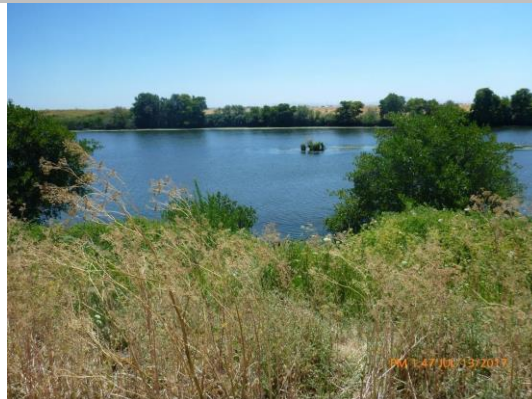
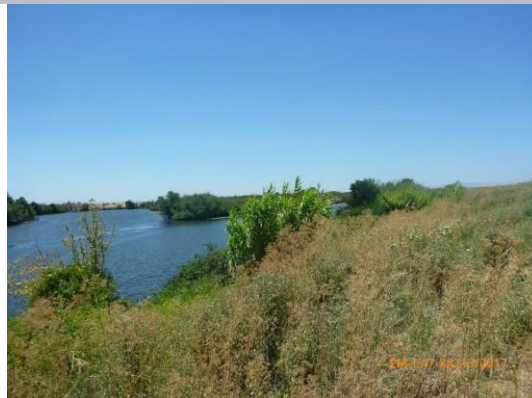
LM Start	<b>3.67</b>	Rating **	M	Issue No.	<b>28</b>
LM End	<b>3.67</b>	Issue Type +	Ma	Location *	
Category	Supplemental			GPS Latitude/Longitude	
				Start	End
Item	2017 Storm Damage			38.261181 °	38.261167 °
				-121.749542 °	-121.749592 °
DWR ID	DWR_RD2060_01_f_2017_28				
Comment Code					
Inspector Comment					
Levee Evaluation Comments Description: Erosion is concentrated near the water line. Site ID No: 374 Site Designation: LMA-201 Repair Type: Erosion Rating: Area of Concern Field Date: 7/13/2017 Notes: Small narrow and deep cut. May have been caused by a collapsed beaver den.

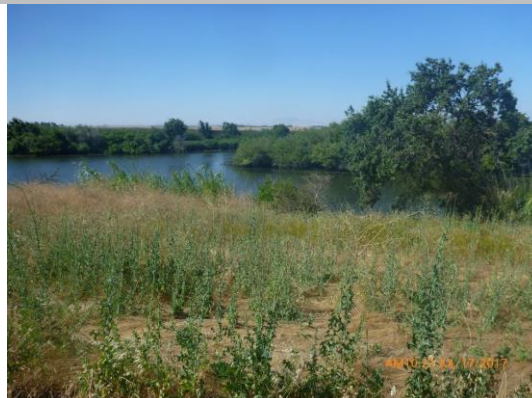
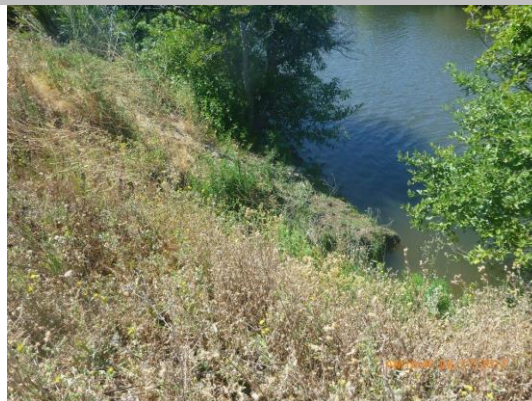
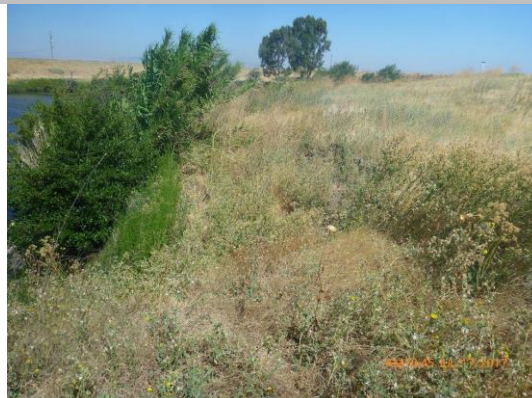
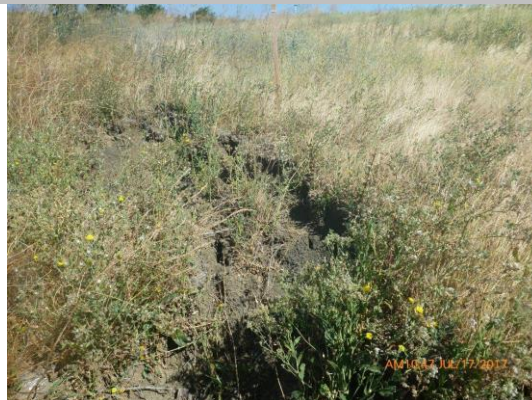
Photo 3 of 3 : FA\_2018\_RD2060\_241\_34\_20180925\_00070.jpg

LM Start	<b>5.00</b>	Rating **	M	Issue No.	<b>34</b>
LM End	<b>5.01</b>	Issue Type +	Ma	Location *	
Category	Supplemental		GPS Latitude/Longitude		
			Start	End	
Item	2017 Storm Damage		38.262636°	38.262658°	
			-121.770503°	-121.770547°	
DWR ID	DWR_RD2060_01_f_2017_34				
Comment Code					
Inspector Comment					
<p>Levee Evaluation Comments</p> <p>Description: Erosion is concentrated mostly near the water line and has resulting in slippage of the slope into the toe.</p> <p>Site ID No: 381</p> <p>Site Designation: LMA-208</p> <p>Repair Type: Erosion</p> <p>Rating: Area of Concern</p> <p>Field Date: 7/17/2017</p> <p>Notes: Extended site from 15' to 75' to include LMA-209. Small erosions will become 1 site next high water due to sloughing between them.</p>

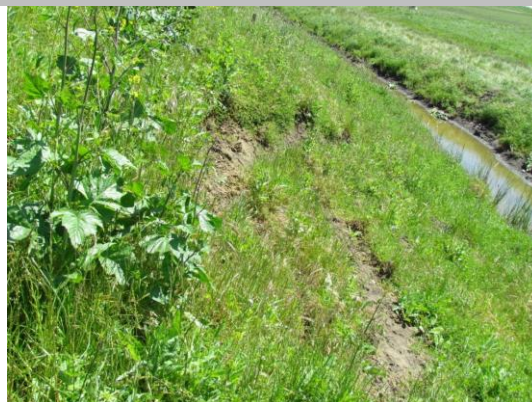
LM Start	0.15	Rating **	A/W	Issue No.	19
LM End	0.19	Issue Type +	Ma	Location *	LS
Category	Earthen Levee			GPS Latitude/Longitude	
				Start	End
Item	Slope Stability			38.295738 °	38.295559 °
				-121.746293 °	-121.745583 °
DWR ID	DWR_RD2060_03_s_2017_19				
Comment Code					
S1 : Repair slope instability.					
Inspector Comment					
There are several signs of sloughing occurring on the slope notices after the flood event Feb. 2017 storm. 10/11/17: This issue's rating has been changed from U to A/W in consideration of the DWR 2017 Levee Evaluation Storm Site entry.

Standing at levee mile 0.15 looking downstream from the landside slope.

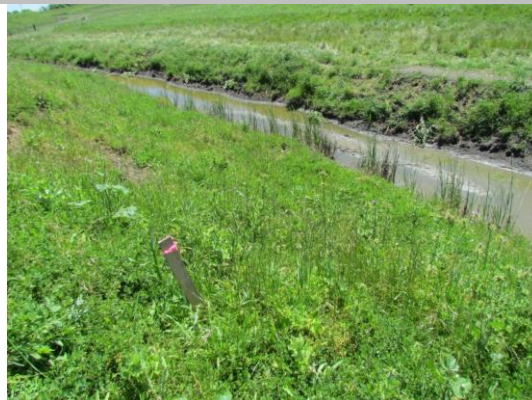
Just upstream of the erosion site looking downstream from the landside slope.

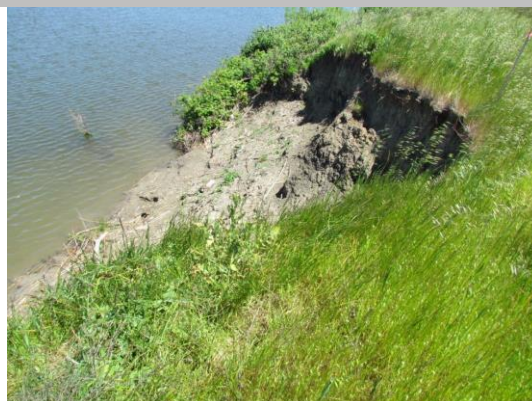
Looking downstream at the erosion in the waterside slope and toe.

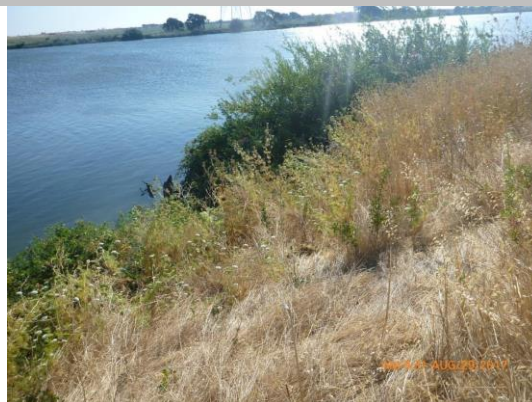
LM Start	1.38	Rating **	M	Issue No.	21
LM End	1.42	Issue Type +	Ma	Location *	
Category	Supplemental			GPS Latitude/Longitude	
				Start	End
Item	2017 Storm Damage			38.290067 °	38.289608 °
				-121.726839 °	-121.726344 °
DWR ID	DWR_RD2060_03_f_2017_21				
Comment Code					
Inspector Comment					
Levee Evaluation Comments					
Description:MBK Delta Erosion Sites_6-29-2017					
Site ID No:482					
Site Designation:LMA-320					
Repair Type: Erosion					
Rating:Area of Concern					
Field Date:8/29/2017					
Notes:

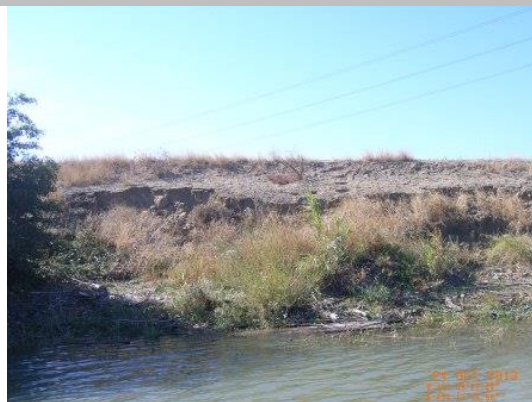
LM Start	1.52	Rating **	A/W	Issue No.	7
LM End	1.74	Issue Type +	Ma	Location *	WS
Category	Supplemental			GPS Latitude/Longitude	
				Start	End
Item	2017 USACE Erosion Survey, DRAFT			38.288598 °	38.286051 °
				-121.725184 °	-121.722818 °
DWR ID	DWR_RD2060_03_f_2018_7				
Comment Code					
Inspector Comment					
2017 Site ID: CHS 23.6 R					
Status: Eroding					
2017 Field Notes: No observed changes.					
Site History: Site added in 1997 and removed in 2003. 2005 - Put back in the inventory. 2006 - Stone repair at the middle of the site. 2011 - Some rock place at toe in the past year. 2013 - Site extended both upstream and downstream to include new erosion pockets.

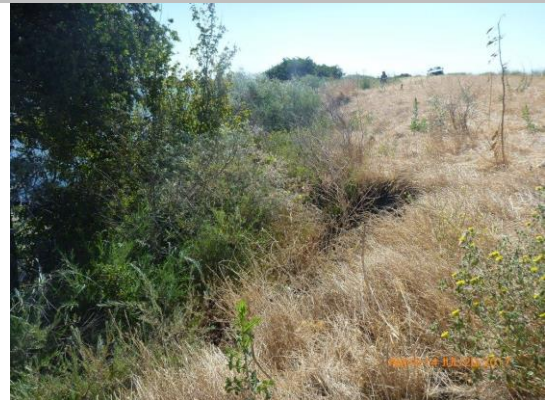
LM Start	<b>1.65</b>	Rating **	M	Issue No.	<b>24</b>							
LM End	<b>1.73</b>	Issue Type +	Ma	Location *								
Category	Supplemental		GPS Latitude/Longitude									
			Start	End								
Item	2017 Storm Damage		38.286953°	38.285939°								
			-121.723958°	-121.723061°								
DWR ID	DWR_RD2060_03_f_2017_24											
Comment Code												
Inspector Comment												
Levee Evaluation Comments Description: Erosion commences halfway down the slope. Existing rip rap has sloughed into the water side toe. Site ID No: 394 Site Designation: LMA-221 Repair Type: Erosion Rating: Area of Concern Field Date: 7/20/2017 Notes: Site includes LMA-218. Erosion halfway down slope. Monitor for progression.

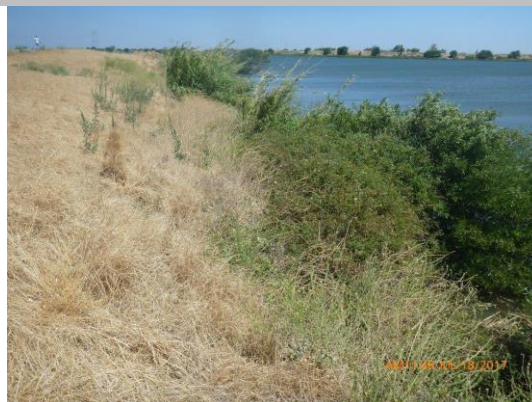
LM Start	2.36	Rating **	M	Issue No.	31
LM End	2.43	Issue Type +	Ma	Location *	
Category	Supplemental			GPS Latitude/Longitude	
				Start	End
Item	2017 Storm Damage			38.280208 °	38.279336 °
				-121.714853 °	-121.714172 °
DWR ID	DWR_RD2060_03_f _ 2017_31				
Comment Code					
Inspector Comment					
Levee Evaluation Comments					
Description:Erosion commences approximately halfway down the slope and results in slippage into the waterside toe.					
Site ID No:400					
Site Designation:LMA-227					
Repair Type: Erosion					
Rating:Area of Concern					
Field Date:7/18/2017					
Notes: Steep cut but protected with heavy woody veg.
